# Fracture resistance and failure mode of three esthetic CAD-CAM post and core restorations

**Aim of the study** This study aimed to evaluate the fracture resistance of three non-metallic esthetic post and core restorations and their modes of failure.

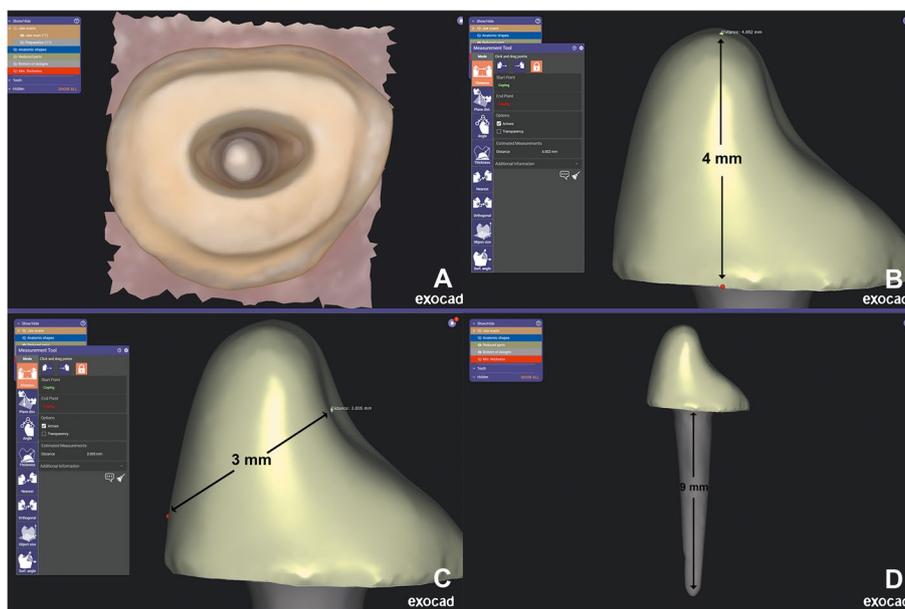
**Fig. 1** A Scanned specimens with post space. B and C CAD of post and core restoration showing core with 4 mm length and labiolingual diameter of 3mm measured diagonally. D Final CAD of post and core. CAD, computer-aided design

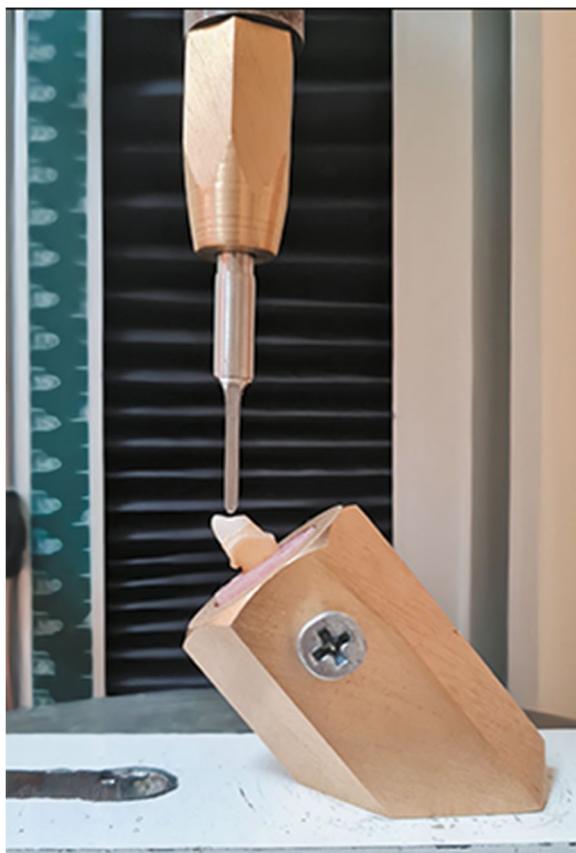
**Fig. 2** Compressive static load applied 45° palatal to specimen

The specimens were mounted in a cylindrical metal holder with an inclination of 45-degree as shown in (Fig. 2). The specimens were subjected to fracture test using a universal testing machine (5ST; Tinius Olsen). A custom-made blunt rounded chisel head (2 mm in size) was used to apply force at a crosshead speed of 1 mm/min. The force was applied at a 135-degree angle to the tooth's long axis, targeting the palatal surface, positioned 2 mm cervical to the incisal edge [47]. Each specimen's failure load was recorded in Newton. Failure was defined as the point at which the strain-stress diagram abruptly dropped, and fracture resistance was recorded as the moment at which the loading force reached its maximum value [48].

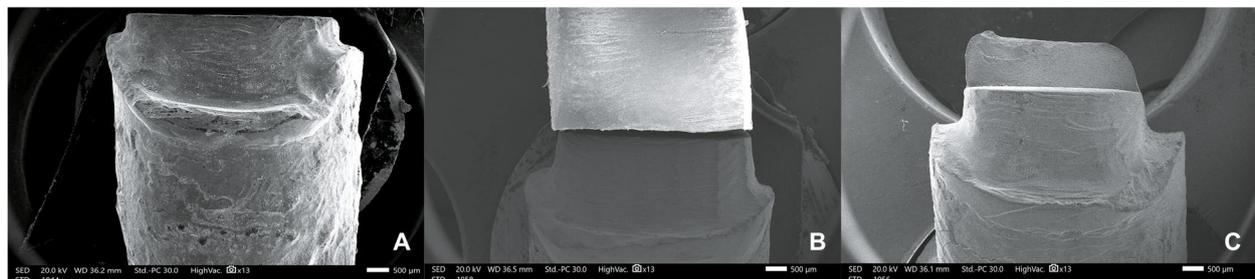
**Fig. 3** Scanning electron micrographs at 13 X magnification of three tested groups displaying favorable failure patterns: **A** FRC with core separated from post. **B** PEEK specimen with a gap between post and core restoration and tooth indicating dislodgement of restoration. **C** PICN specimen with fracture within core

Examining samples visually and using scanning electron microscope (SEM) and stereomicroscope imaging revealed distinct fracture patterns. In FRC samples, observations indicated favorable fractures marked by core separation that didn't impact the post or tooth

(Figs. 3A, 6A). Conversely, unfavorable outcomes included post damage and vertical root fractures below the CEJ (Figs. 4A, 7A). SEM images also revealed a pattern of brush-like cracking attributed to the rupture of these fibers (Fig. 5A) [52].

PEEK samples that exhibited favorable fractures underwent dislodgement without causing fractures in any component (Figs. 3B, 6B). Nevertheless, the unfavorable failures were distinguished by vertical root fractures occurring below the CEJ without any accompanying

In PICN, the favorable failure mode involved fractures within the core segments (Figs. 3C, 6C), contrasting with the unfavorable pattern represented by a vertical root fracture below the CEJ and a fracture in the post (Figs. 4C, 7C). Additionally, SEM micrographs displayed a rough surface, showcasing the heterogeneity of components (Fig. 5C).

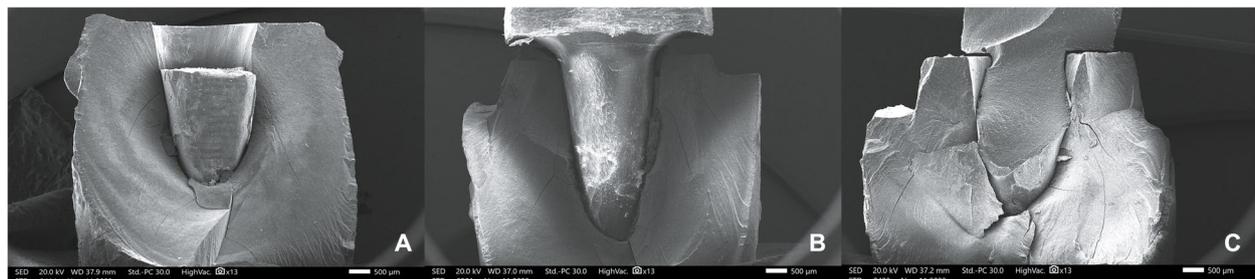
**Fig. 4** Scanning electron micrographs with 13 X magnification of three tested groups with non-favorable failure patterns. **A** FRC sample displayed fractures in both post and core restoration and vertical root fracture below CEJ. **B** PEEK sample exhibited vertical root fracture below CEJ, while post and core restoration remained intact. **C** PICN sample showed fractures in both post and core restoration, and vertical root fracture below CEJ

fractures in the post or the core (Figs. 4B, 7B). The SEM analysis notably showed a smooth surface on the PEEK post (Fig. 5B).

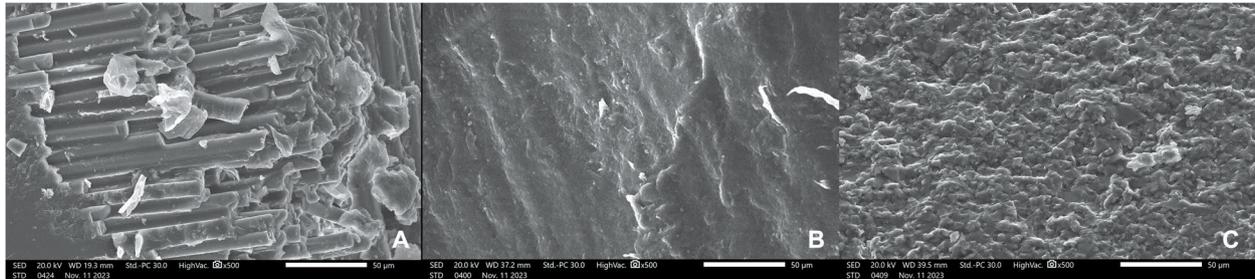
**Fig. 5** Scanning electron micrographs with 500 X magnification of fractured surfaces of three tested groups. **A** FRC specimen with failed post showing ruptured fibers with brush-like cracking. **B** PEEK specimen with intact external smooth surface. **C** Rough surface detected after fracture in PICN

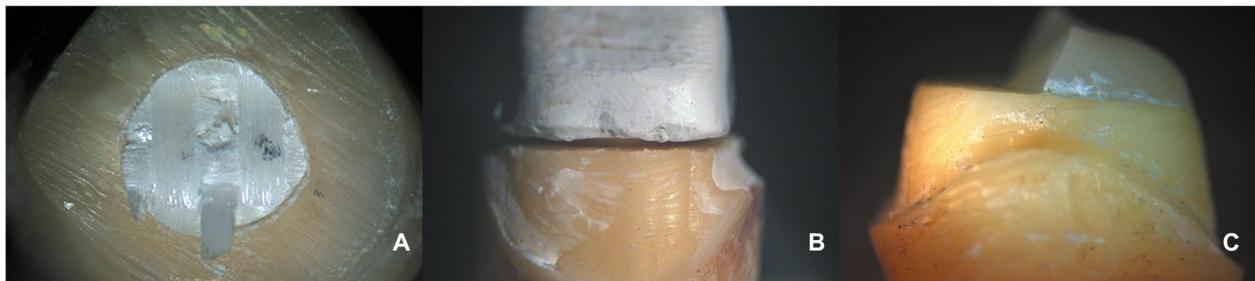
**Fig. 6** Stereomicroscope images with 4 X magnification showing favorable fracture patterns in three tested groups. **A** FRC sample displayed core separation. **B** PEEK sample exhibited post and core dislodgment. **C** PICN sample fractures confined within the core

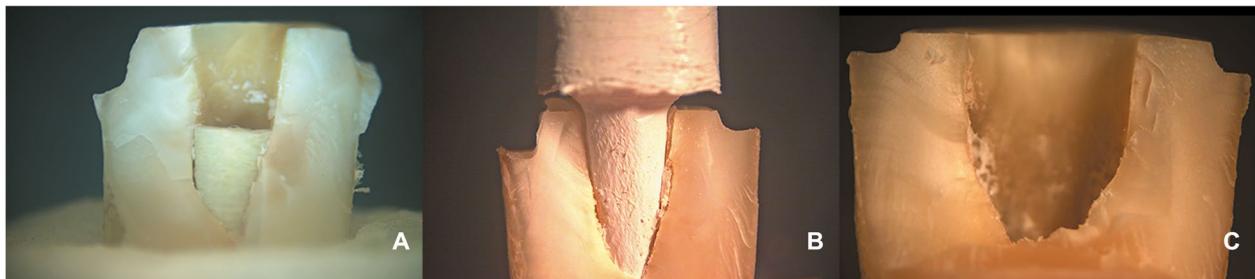
**Fig. 7** Stereomicroscope images with 4 X magnification showing unfavorable fracture patterns in three tested groups: **A**, FRC sample displayed fractures in both post and core restoration and vertical root fracture below CEJ. **B**, PEEK sample exhibited vertical root fracture below CEJ, while post and core restoration remained intact. **C**, PICN sample showed fractures in both post and core restoration, and vertical root fracture below CEJ
